Case Report

Direct Composite Laminate Veneers: Three Case Reports

J Dent Res Dent Clin Dent Prospect 2013;7(2):105-111 | doi: 10.5681/joddd.2013.019

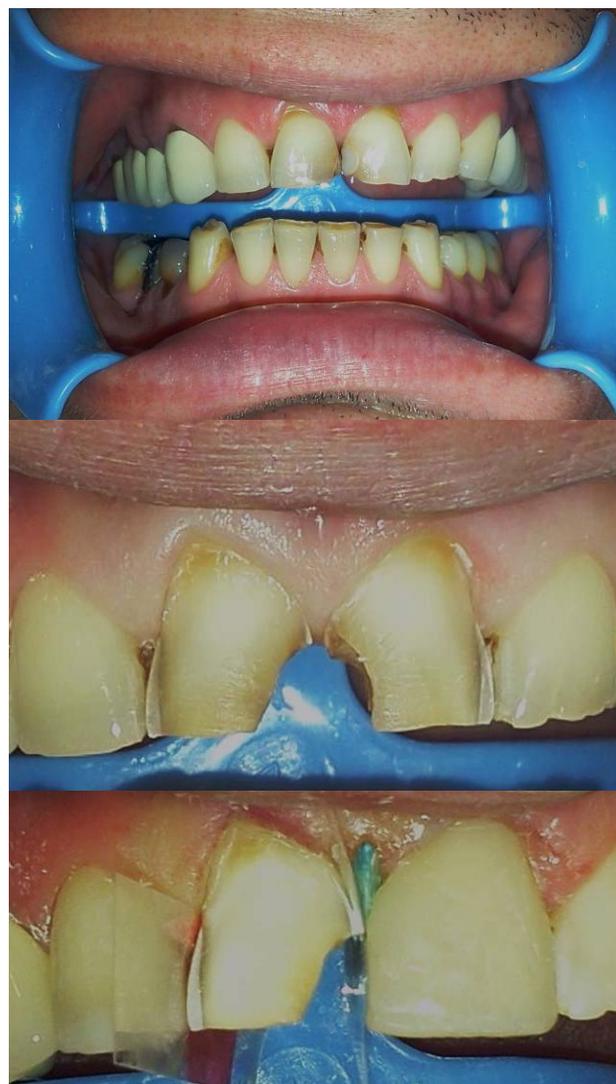
A 37-year-old male patient with incisal edge fractures of maxillary central incisors, and therefore with esthetic complaints, referred to the faculty clinics. Old composite restorations, surrounded with secondary caries, were detected at the mesial edges of maxillary central incisors of the patient after clinical and radiographic examinations. Moreover, attritions involving enamel and also dentin tissues at the incisal edges of maxillary and mandibular central incisors, due to a possible bruxism problem, were noted (Figure 1a).

Figure 1. Secondary carious lesions at mesial margins of upper central incisors (a). Cervical step preparations (b). Transparent matrix band and wedge application (c).

Following local anesthetics for maxillary centrals, old restorations were removed with a high-speed handpiece (NSK Pana Air, Japan) and a round diamond bur (Acurata, Germany) under water cooling; 0.8-mm-deep walls were prepared on the labial surfaces of the teeth. Cervical borders of the preparations were arranged just at the same line of the gingiva by setting a cervical step without impinging on the natural gingival contour (Figure 1b).

parent matrix bands were cut, applied and fixed with appropriate wedges (Figure 1c). Then, 37% phosphoric acid (Etching Gel, Kerr, USA) was applied on the enamel surfaces for 15 seconds, rinsed with water spray for 20 seconds and dried slightly. One-bottle bonding agent (Adper Single Bond, 3M ESPE, USA) was applied in two layers on the prepared tooth surfaces by using a bonding brush and polymerized with a light-curing unit (Demi LED Light Curing System, 450 nm, Kerr, USA) for 20 seconds. In order to prevent any dark color reflection on the prepared surfaces, opaque A2 shade composite resin (Herculite XRV Ultra, Kerr, USA) was applied to the palatal sides and polymerized with a light-curing unit. Later, the cavities were filled with A2 shade of composite resin (Herculite XRV Ultra, Kerr, USA) incrementally and polymerized each time for 40 seconds.

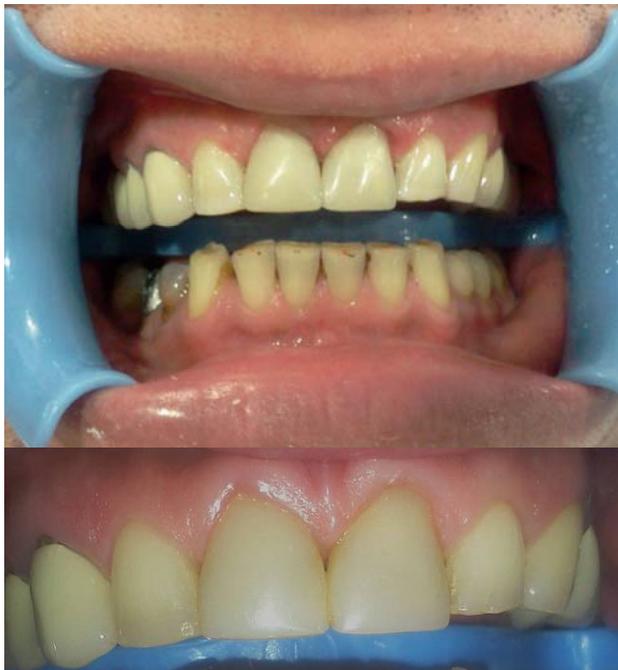
The patient was instructed in the oral hygiene and called at 6 months. At 6-month recall, no discolorations or disintegrations were detected (Figure 2b).

Figure 2. Finishing and polishing (a). Six-month recall, no discolorations or disintegrations (b).

For finishing and polishing procedures, first a yellow-banded knife-edge bur (Acurata, Germany) was used in a high-speed handpiece (NSK Pana Air, Japan). For advanced polishing, discs (Ultra Gloss Composite Polishing System, Axis, USA) in different dimensions were used from coarse to fine grits (Figure 2a).

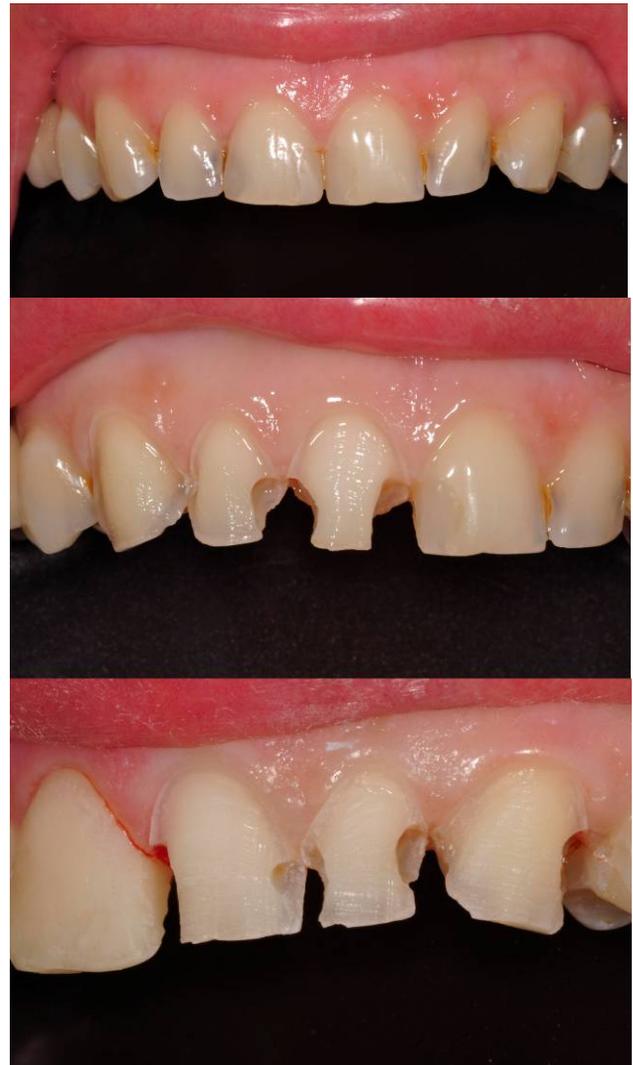
plaints due to some stains on maxillary anteriors, presented to our faculty clinics. She also emphasized that her teeth were too small and she was not happy with this. After clinical and radiographic examinations, old composite resin restorations on teeth #11 and #21 and carious lesions on #12, #22 and #23 were detected (Figure 3a). The remaining tooth structures were adequate for composite laminate veneer restorations.

Figure 3. Upper incisors with carious lesions (a). Preparations with cervical steps (b,c).

A2 shade was selected with GC shade guide. After the former restorations and the carious lesions were removed, direct composite restorations were considered treatment of choice due to small amount of remaining dental tissues of the teeth. Teeth #13 and #23 were also included in the treatment plan due to some stains and discolorations in order to achieve better esthetic results (Figure 3b,c). Laminate veneer preparations of labial surfaces were arranged to be limited within enamel borders. Preparation of cervi-

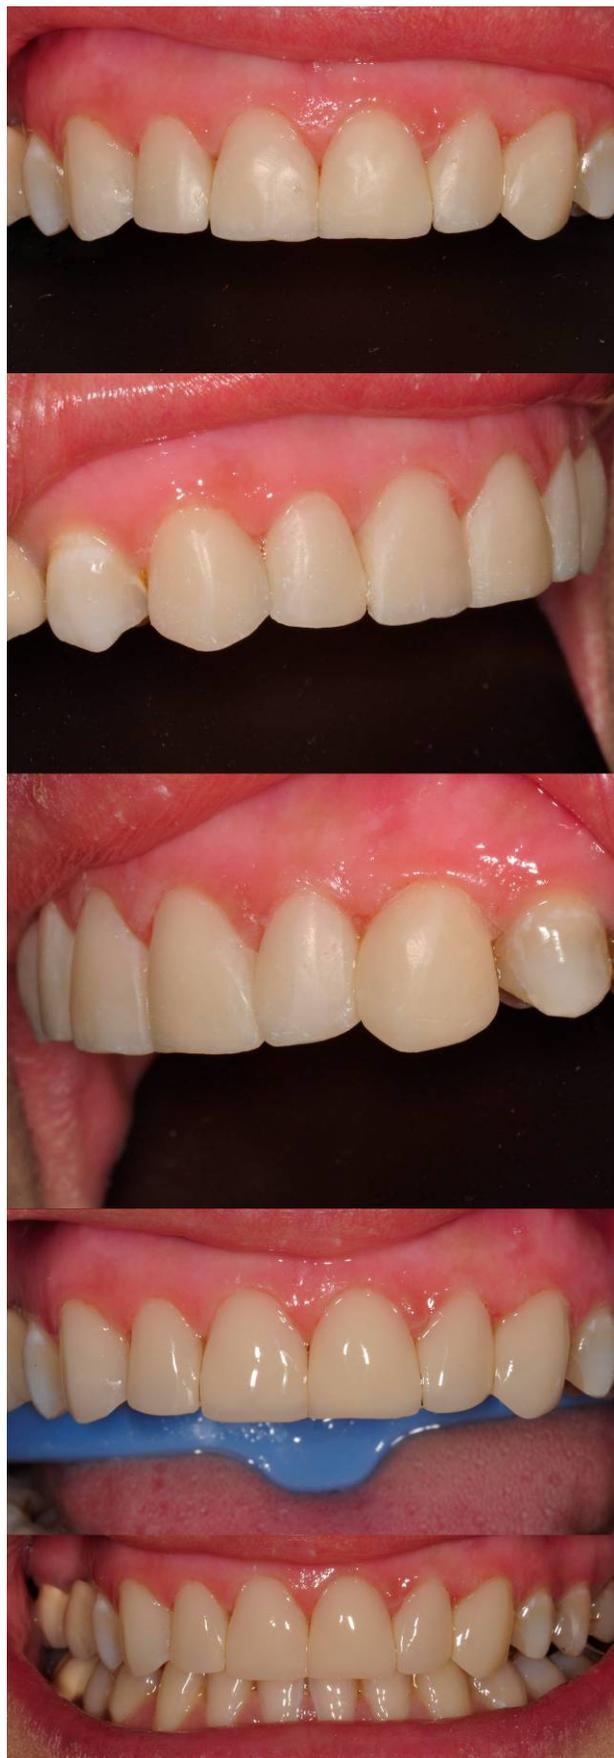
Figure 4. Composite restorations finished (a). Finishing (b,c). Polishing (d,e).

As the preparations finished, translucent matrix bands, covering both the mesial and distal sides of the teeth, were applied to the cervical area and fixed with appropriate wedges; 37% phosphoric acid (Etching Gel, Kerr, USA) was applied for 15 seconds, rinsed with water spray for 20 seconds and slightly dried. A one-bottled bonding agent (Adper Single Bond, 3M ESPE, USA) was applied in two layers to prepared surfaces and polymerized with the light-curing unit for 20 seconds. An A2 dentin shade composite resin material (GC Gaenial, GC Corp., Tokyo, Japan) was applied palatally on the deep cavities of teeth #12, #11, #21, #22 and #23 and polymerized with the light-curing unit for 40 seconds. Then, A2 enamel shade of composite material (GC Gaenial, GC Corp., Tokyo, Japan) was applied gradually to the whole labial areas of the teeth and polymerized for 40 seconds every time (Figure 4a).

Finishing was achieved with a yellow banded diamond bur (Acurata, Germany) in a high-speed handpiece (Figure 4b,c). Then, polishing discs (Ultra Gloss Composite Polishing System, Axis, USA) were used in a low-speed handpiece (DURAtec 2068D, Germany) for fine polishing from coarse to fine grits (Figure 4d,e).

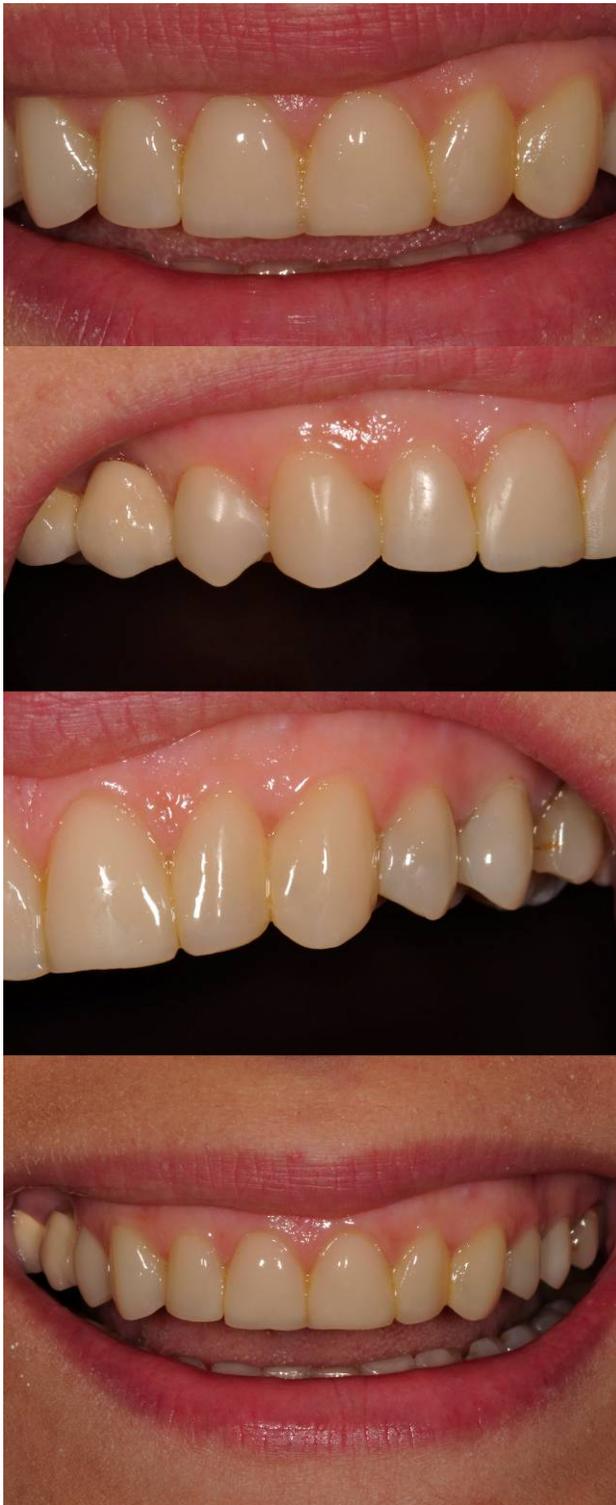
The patient was instructed in oral hygiene and was scheduled for control appointments once every 6 months. On the 6-month appointment, some discolorations on the contact areas of the teeth were detected (Figure 5a). However, the patient was very pleased with the current esthetic situation of her teeth so she wanted her premolars being treated with the same method. After clinical examination, teeth #14, #24 and #25 were considered for treatment with direct restorations (Figure 5b,c). As the restorations finished (Figure 5d), the patient was asked to use dental floss every day at contact areas.

Figure 5. Six-month recall; some discolorations at contact areas (a). Additional restorations to teeth #14, #24 and #25 (b,c). Composite restorations finished (d).

In case 2, the discolorations on the contact areas on the 6-month recall can be related to the insufficient dental hygiene and no use of dental floss. These were the discolorations which can be easily removed by slight polishing. The patient was also instructed in the use of dental floss so that she would not have any

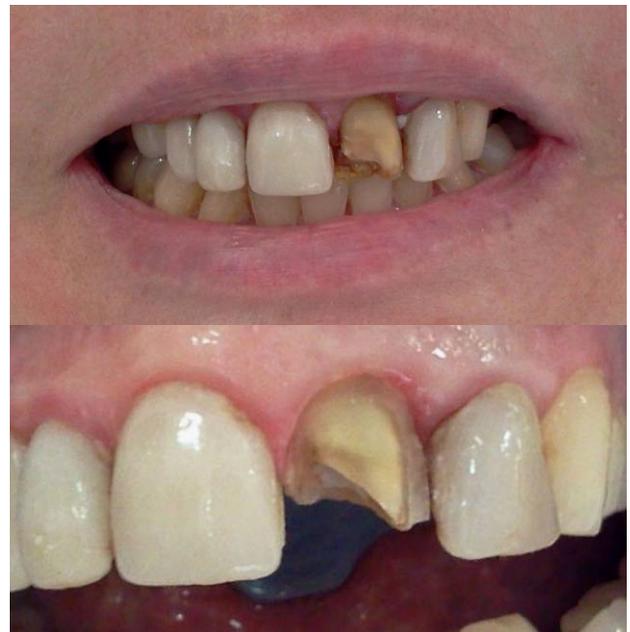
A 45-year-old female with esthetic complaints due to a prolapsed ceramic laminate veneer restoration on maxillary left central incisor referred to the faculty clinics. The patient reported that the ceramic laminate veneer restorations were nearly 1 year old and only the prolapsed one had caused problem. Moreover, the prolapsed restoration was lost. Carious lesions were detected on the mesial and labial surfaces of maxillary left central incisor clinically (Figure 6a). No sensitivities to percussion were detected horizontally and vertically. In radiographic examination, a previous endodontic treatment was detected

Figure 6. Prolapsed restoration of tooth #21 (a). Cervical step preparations (b).

First, infected tooth structures were removed with a low-speed handpiece (DURAtec 2068D, Germany) and a stainless steel round bur (Acurata, Germany). Cervical borders of the preparation were arranged just at the same line with the gingiva (Figure 6b).

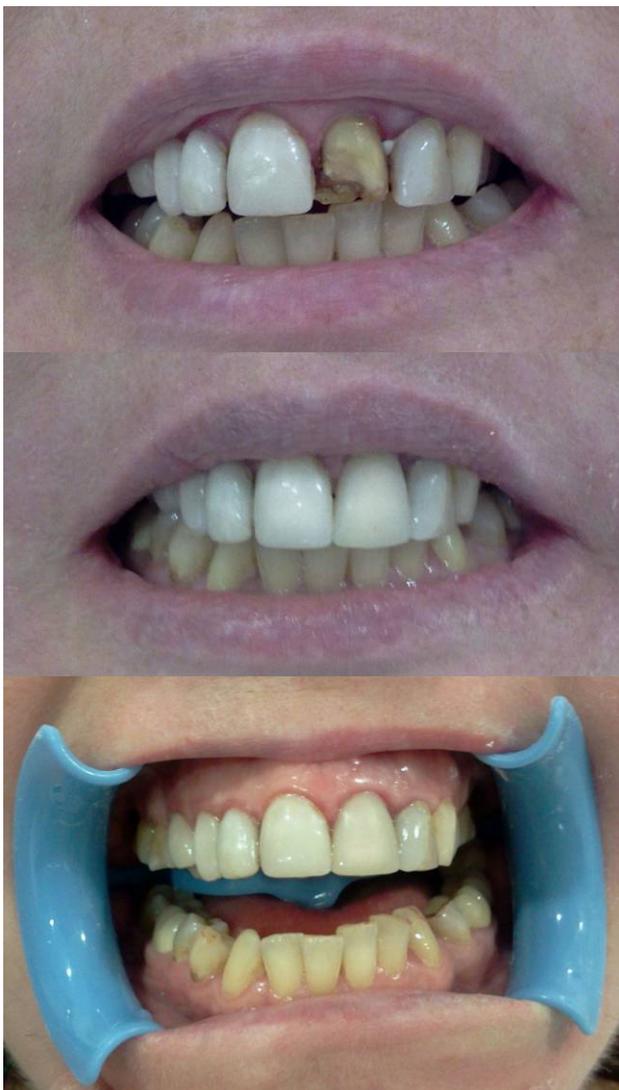
Figure 7. Before treatment (a), and after finishing and polishing (b). Six-month recall, no discolorations or disintegrations (c).

month recall (Figure 7c).

Finishing and polishing processes were carried out with a yellow-banded diamond bur (Acurata, Germany), immediately followed by polishing discs (Ultra Gloss Composite Polishing System, Axis, USA). The polishing discs were used in a low-speed handpiece (DURAtec 2068D, Germany) from coarse to fine grits (Figure 7a,b).
